LONG-TERM RAIL PAD TEST IN BRAZIL

CASE STUDY

Heavy Traffic Routes
Brazil (BR)

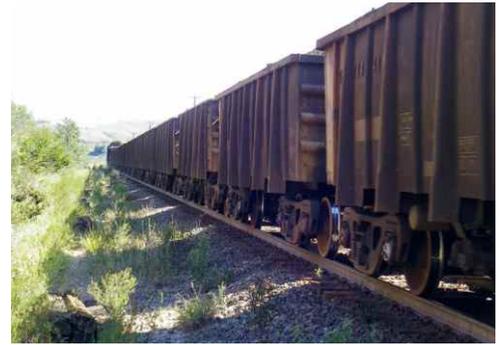
The trains on the heavy traffic route are approximately two kilometres in length

MRS Logística S.A. has been operating a heavy traffic route for transporting iron ore, container goods and coal from the interior of the country to the east coast since 1996. The 1,674 kilometre route crosses the three federal states of Rio de Janeiro, Minas Gerais and São Paulo, and is constantly subjected to extremely heavy loads. Each train on the line is approximately two kilometres in length and has an average axle load of 33 metric tons.

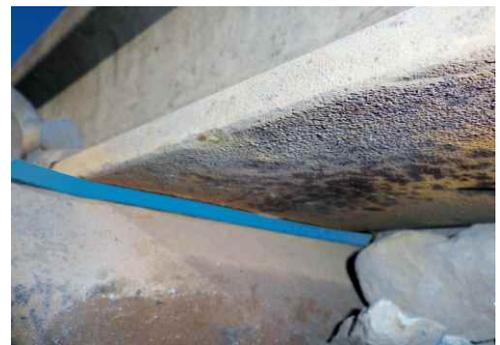
Installed rail pad

Getzner rail pads can be installed or retrofitted quickly and easily. They are placed directly under the rail base. The installation process is quick and does not require a long closure period.

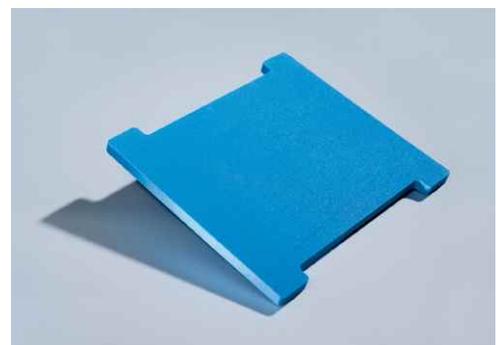
Sylodyn® rail pads

The main reason for the high degree of wear to all the superstructure components is a lack of elasticity. That is why in October 2011, MRS Logística S.A. - working under the guidance of Getzner specialists - installed high-strength Sylodyn® rail pads on steel and timber sleepers on a section of the heavy traffic route in Ferrovia do Aço (near Bom Jardim de Minas). Joao Marcos, project manager at Getzner, explains: "The ballast on the test track in Brazil has been destroyed or extremely compressed, with the result that there is no elasticity at all in the entire superstructure. Our rail pads compensate for this lack of elasticity."

In Autumn 2017, some of the rail pads were removed to check their condition. "We needed to get a feel for the loading that the material had been subjected to for six years. Both a visual inspection and the results of elastic property measurements in the laboratory demonstrated that our rail pads showed no signs of wear whatsoever. This means that characteristics such as dynamic stiffness are still the same as specified during installation," says Joao Marcos.
