Case Study

Long-Term Test of Rail Pads on a Heavy Traffic Route, Brazil (BR)

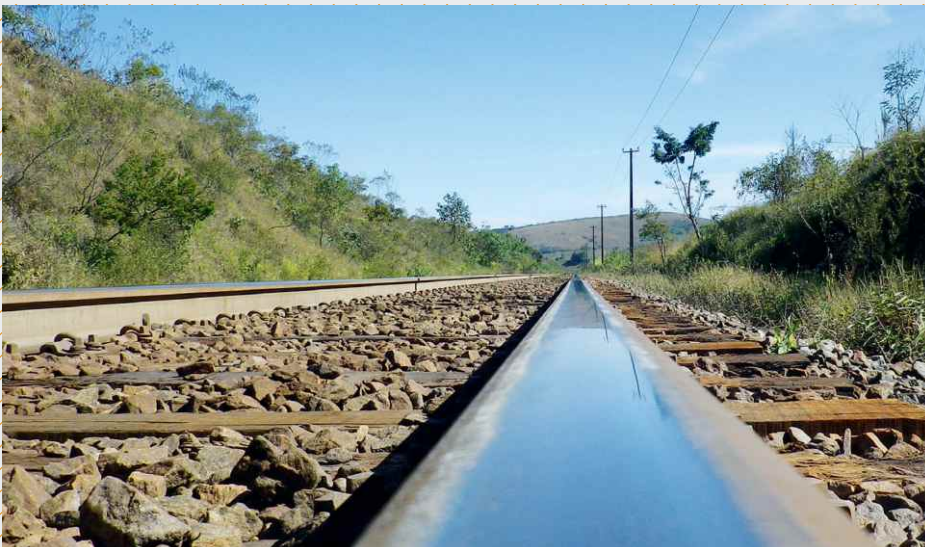
The route is used to transport container goods and coal to the east coast

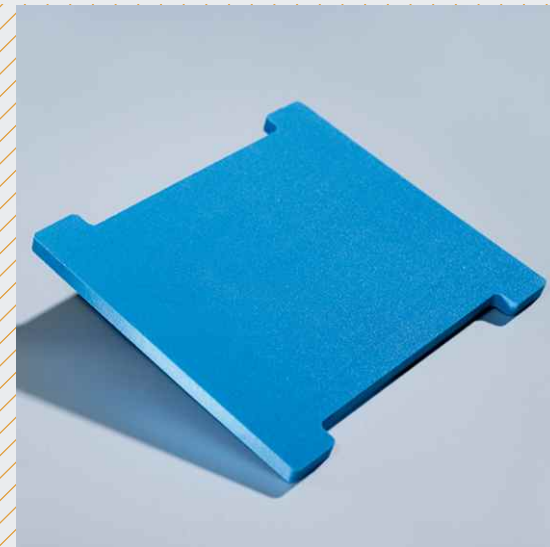
Sylodyn® rail pads

Getzner rail pads can be installed or retrofitted quickly and easily. They are placed directly under the rail base; the installation process is quick and does not require a long closure period.

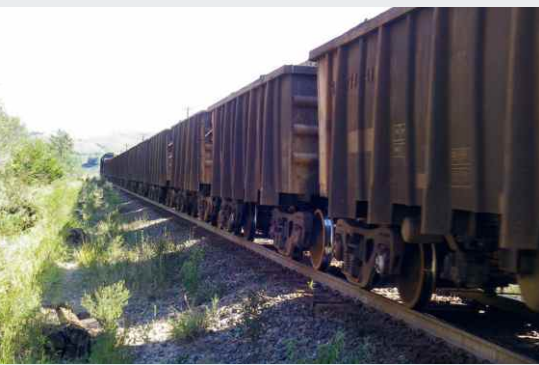
The trains on the heavy traffic route are approximately two kilometres in length

subjected to extremely heavy loads. Each train on the line is approximately two kilometres in length and has an average axle load of 33 metric tons.

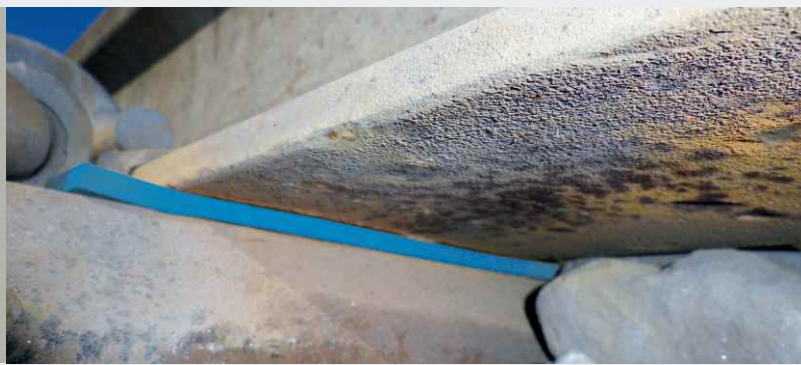
Installed rail pad

of wear on the superstructure components were significantly reduced," summarises Joao Marcos. One of the reasons for this is the measured area of contact between the rail pad and the rail when a train passes over. At 95%, this value is very high - resulting in a better load distribution and less wear.

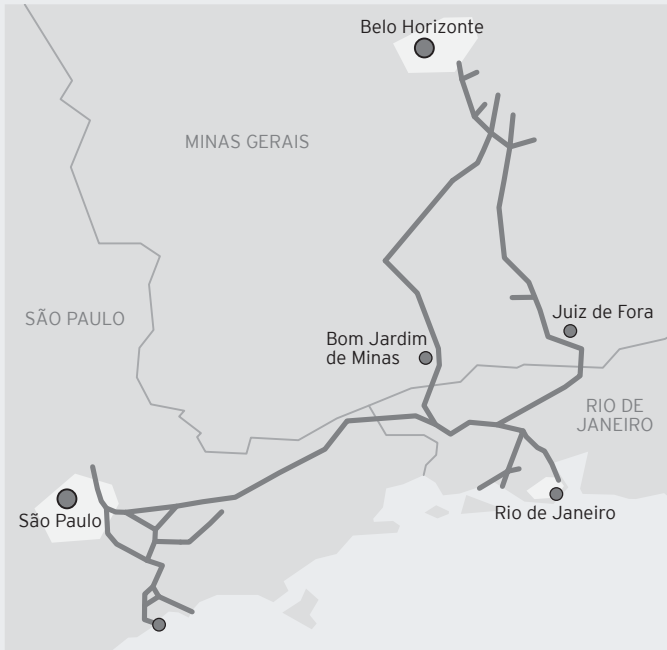
Current MRS Logistica S.A. railway network

Operator:	MRS Logistica S.A.
Track length (over which the material was installed):	100 metres including reference sections
Material:	High-strength Sylodyn® rail pads
Loading throughout the entire test period (6 years):	1250 million metric tons
Implementation:	Since October 2011
Getzner Project Manager:	Joao Marcos
